РОССИЙСКИЙ МОРСКОЙ РЕГИСТР СУДОХОДСТВА
RUSSIAN MARITIME REGISTER OF SHIPPING

**ПРИЛОЖЕНИЕ К ПРАВИЛАМ И РУКОВОДСТВАМ
РОССИЙСКОГО МОРСКОГО РЕГИСТРА СУДОХОДСТВА**

**SUPPLEMENT TO RULES AND GUIDELINES
OF RUSSIAN MARITIME REGISTER OF SHIPPING**

**IACS PROCEDURAL REQUIREMENTS,
UNIFIED INTERPRETATIONS
AND RECOMMENDATIONS**

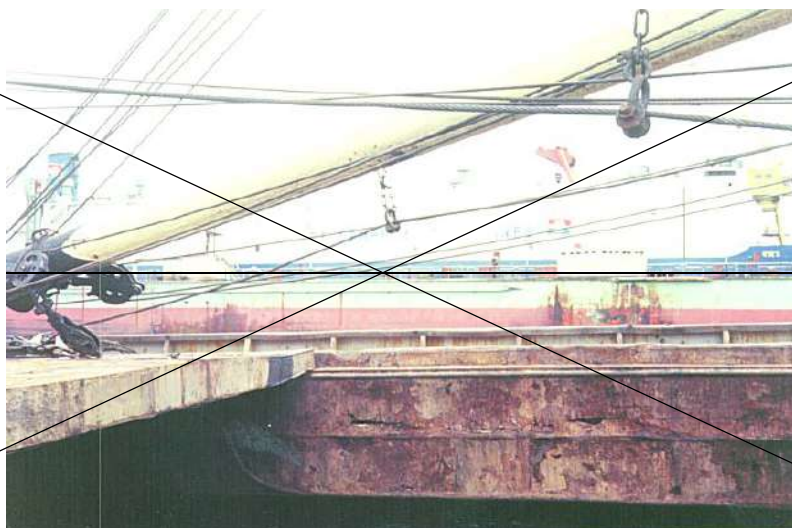
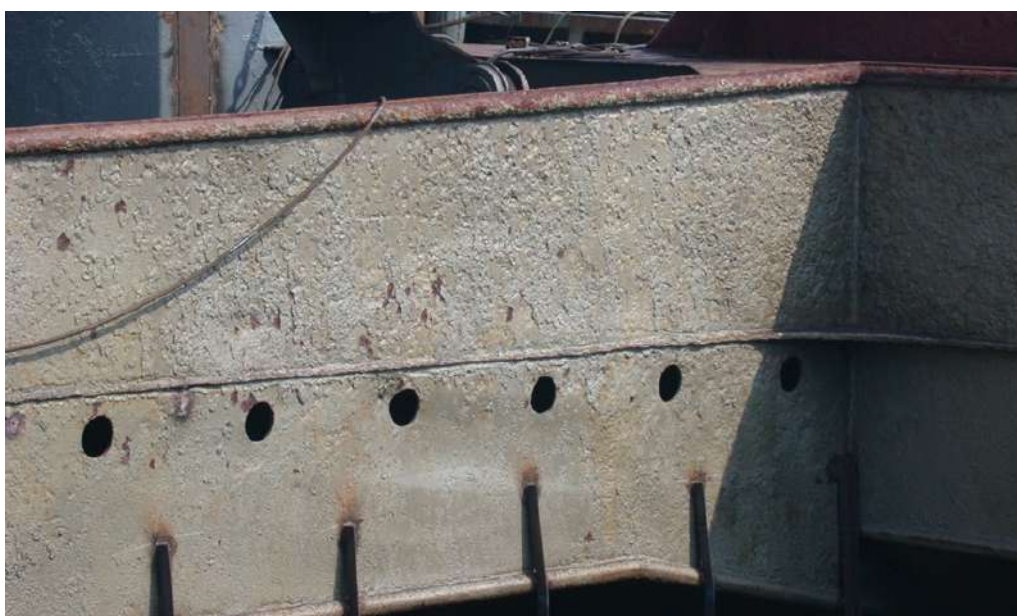
Photograph 1 Heavy corrosion of hatch coaming

- 3.1.1** The level of wastage of under-deck stiffeners/structures may have to be established by means of thickness measurements. As mentioned previously the combination of the effects from the marine environment and the local atmosphere will give rise to high corrosion rates.
- 3.1.2** Severe corrosion of the hatch coaming from inside and of under deck girders may occur due to difficult access for maintenance of the protective coating. This may in turn lead to fractures (See **Photograph 1**).

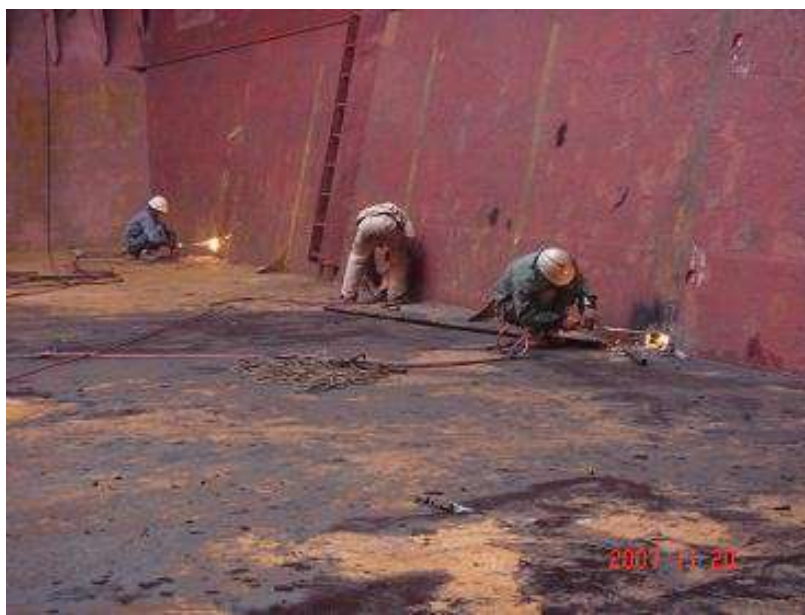
Photograph 1 Heavy corrosion affecting inner bottom plating

- 2.1.2 When the tank top plating has been covered with dunnage or ceiling the plating may have suffered heavy corrosion, due to high humidity, and lack of proper maintenance (See **Photograph 1**).

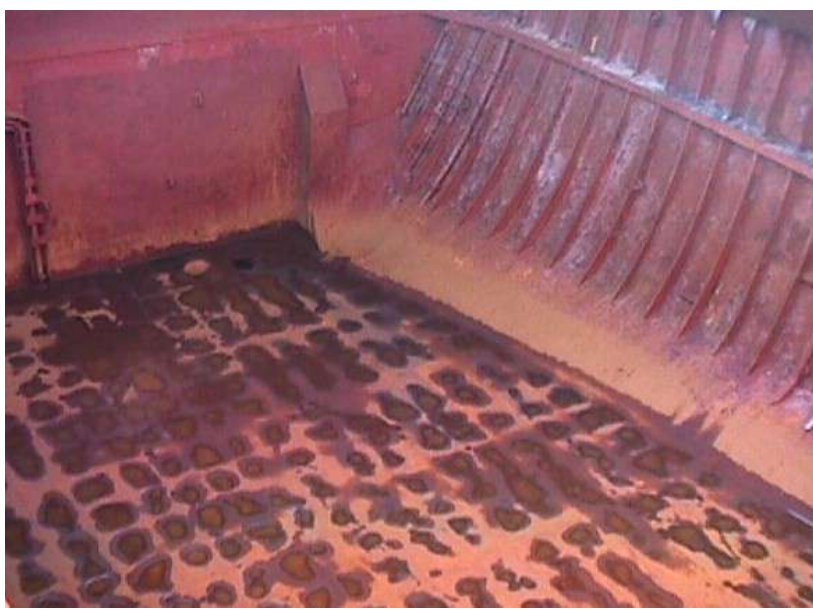
Photograph 2 Damaged inner bottom plating

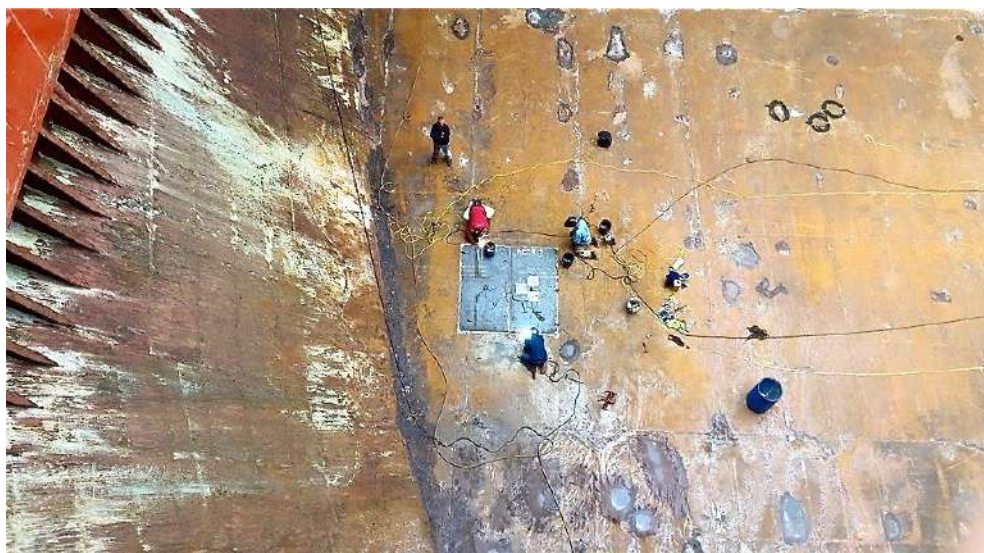
Photograph 3 Repairs of damaged inner bottom plating

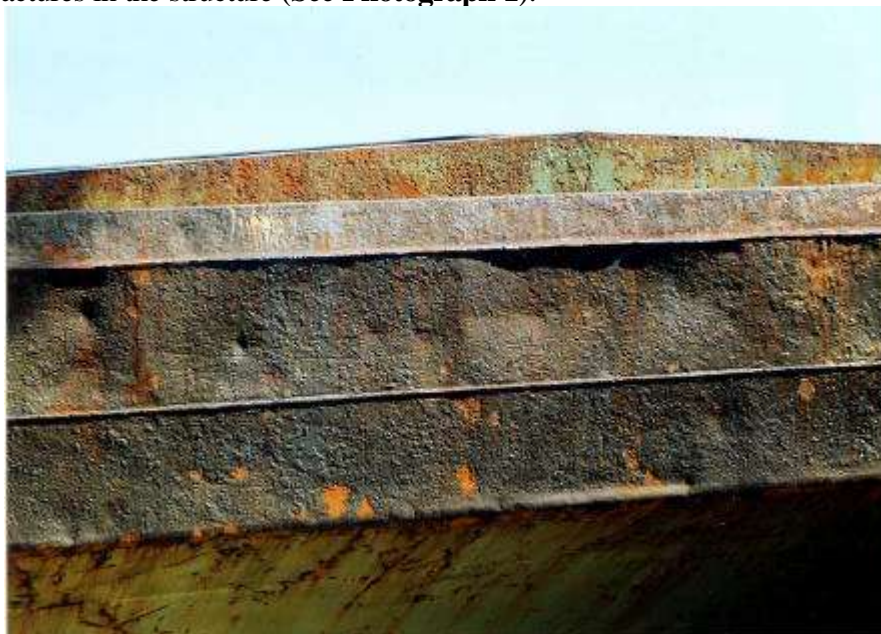
Photograph 1 **Heavy corrosion of hatch coaming and topside tank plating vertical strake**

- 3.1.1** The level of wastage of under-deck stiffeners/structure in cross deck may have to be established by means of thickness measurements. The combined effect of the marine environment and the high humidity atmosphere within cargo hold s will give rise to a high corrosion rate.
- 3.1.2** Severe corrosion of the hatch coaming plating inside cargo hold and topside tank plating vertical strake may occur due to difficult access for the maintenance of the protective coating. This may lead to fractures in the structure (See **Photograph 1**).

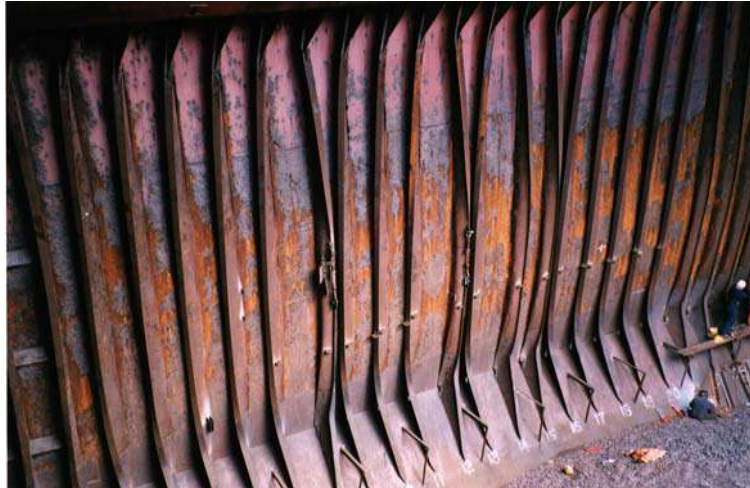
Photograph 1 Collapsed side shell frames (See Example 4)

- 1.6 A summary of potential problem areas is shown in **Figures 1 - 4**. Examples of failure and damaged ship side structure are illustrated in **Photographs 1- 2**.

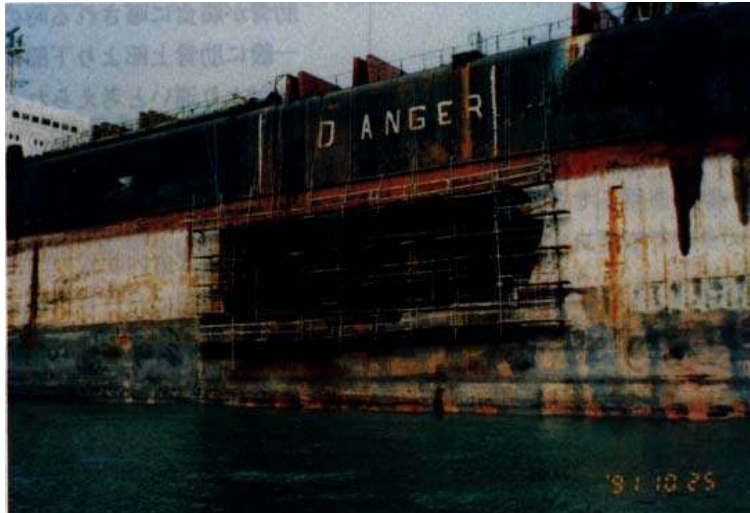
Photograph 2 Missing side shell structure (See Examples 4 and 5)

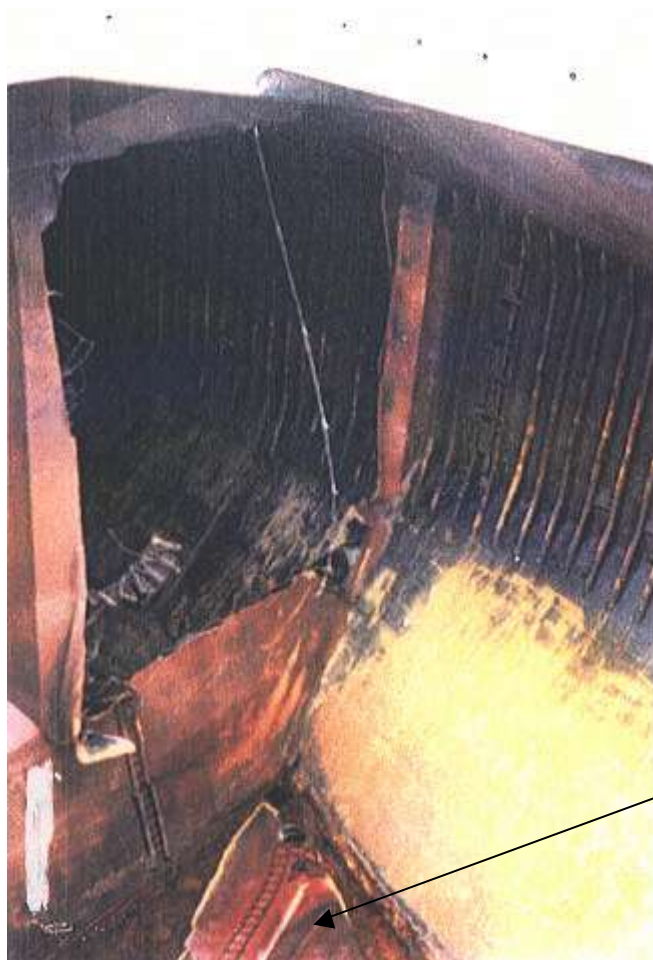
Photograph 1
Collapsed and detached
transverse bulkhead

Collapsed and detached transverse bulkhead on the tank top

- 1.5** Heavy corrosion may lead to collapse of the structure under extreme load, such as indicated in **Photograph 1** if it is not rectified properly.

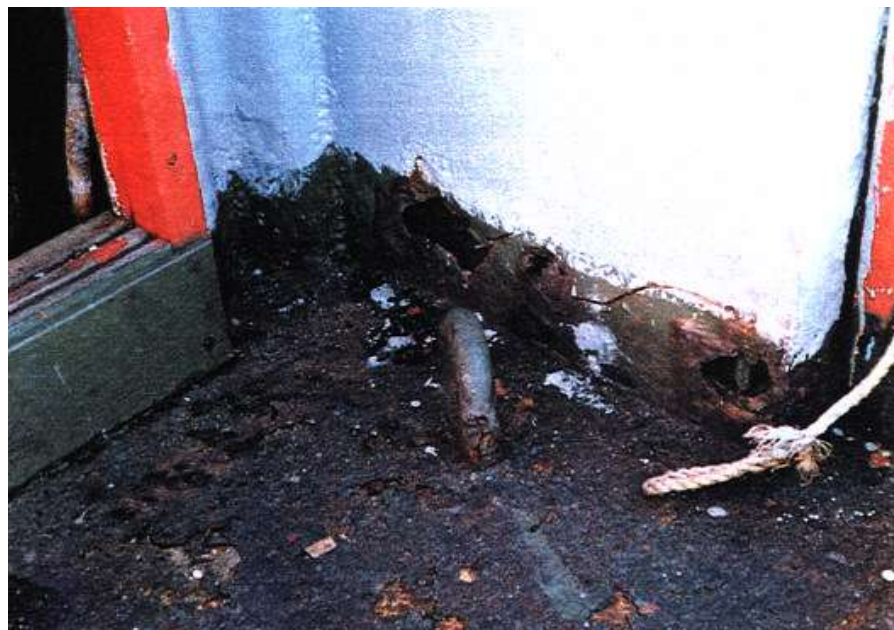
Photograph 1 Corroded accommodation house side structure

Severe corrosion may be found in exposed deck plating and deck house side structure adjacent to the deck plating where water is liable to accumulate (See **Photograph 1**). Corrosion may also be found in accommodation bulkheads around cutout for fittings, such as doors, side scuttles, ventilators, etc., where proper maintenance of the area is relatively difficult. Deterioration of the bulkheads including fittings may impair the integrity of weathertightness.

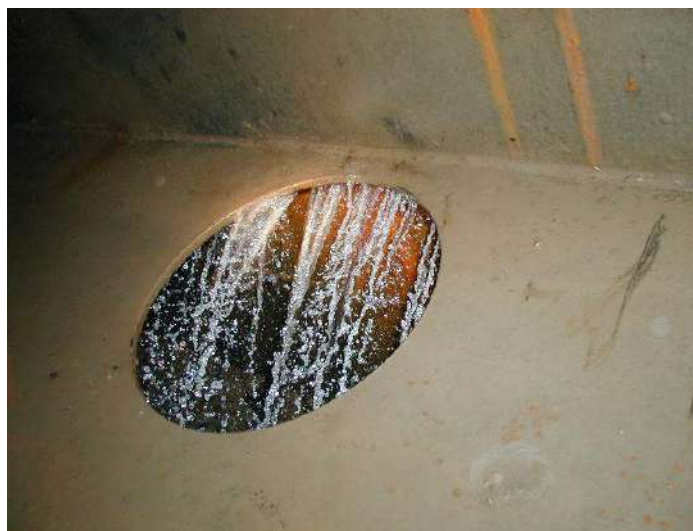
Photograph 1 Side shell fracture in way of horizontal stringer weld

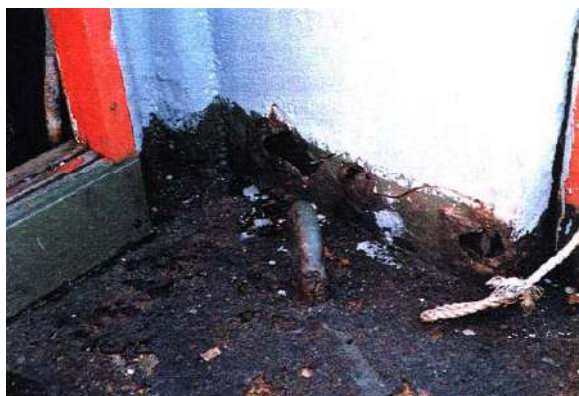
Photograph 1 Corroded accommodation house side structure

Severe corrosion may be found in exposed deck plating and deck house side structure adjacent to the deck plating where water is liable to accumulate (See **Photograph 1**). Corrosion may also be found in accommodation bulkheads around cut-out for fittings, such as doors, side scuttles, ventilators, etc., where proper maintenance of the area is relatively difficult. Deterioration of the bulkheads including fittings may impair the integrity of weathertightness.
